## **A STUDY ON THE EROSION CHARACTERISTICS OF THE MICROPULSED PLASMA NITRIDED BARREL OF A RIFLE**

This study evaluates the erosion characteristics of the nitrided barrel of a rifle. The surface of wear sensor was enhanced by micropulsed plasma nitriding and postoxidation technology. Three types of wear sensors were used to compare the effect of surface treatment such as nitriding and postoxidation as well as without surface treatment. The surface of each sensor had an indent pressed by a Vickers microhardness indenter. The wear was measured by the change of depth of the indent. The cross section of the sensor was analyzed by an optical microscope and SEM after firing 400 rounds.

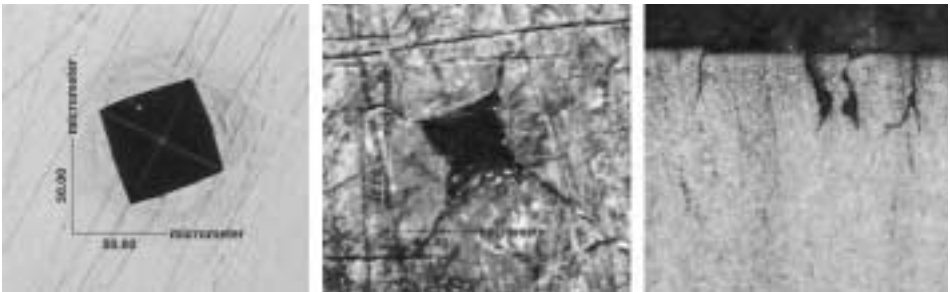
Fig. 4. Surface and cross sectional images of the barrel material (FFZ).

Figure 4–Figure 6 show the surface and cross section of the sensor in the free flight zone (FFZ) of the barrel according to surface treatment. Figure 4 shows images of the barrel material used in the present. It shows that the size of the indent decreases considerably, and the amount of wear after firing 400 rounds is  $2.67\ \mu\text{m}$ . Also as can be seen in the picture, the cracks are propagated into the depth.

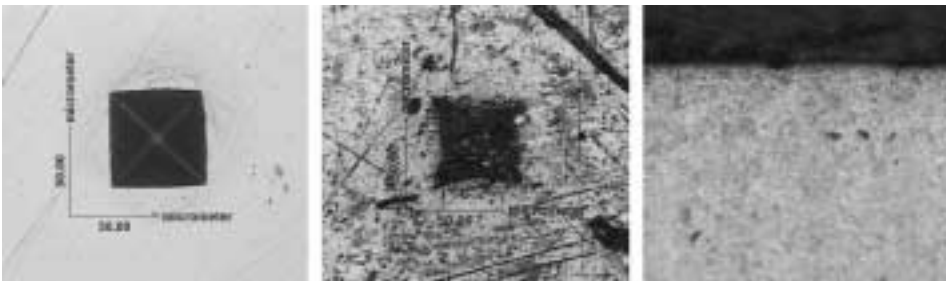
Fig. 7. Surface and cross sectional images of the barrel material (CZ).

Figure 7–Figure 9 show the surface and cross section of the sensors from the center zone (CZ) of the barrel. Figure 7 represents the barrel material used in the present and the amount of wear after firing 400 rounds is  $1.83 \mu\text{m}$ . However as opposed to the free flight zone, there isn't any surface crack or crack propagation into the depth.
